17 Bones Lane

Description

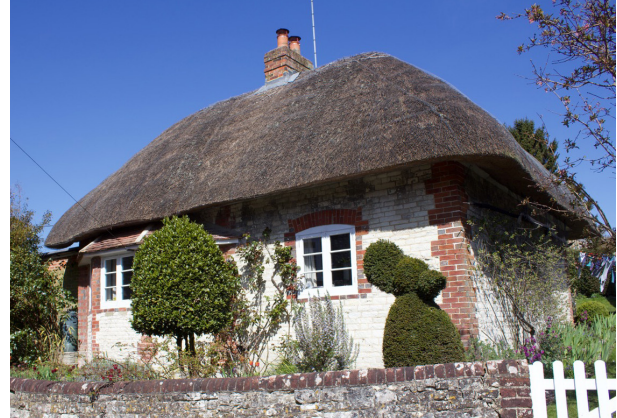
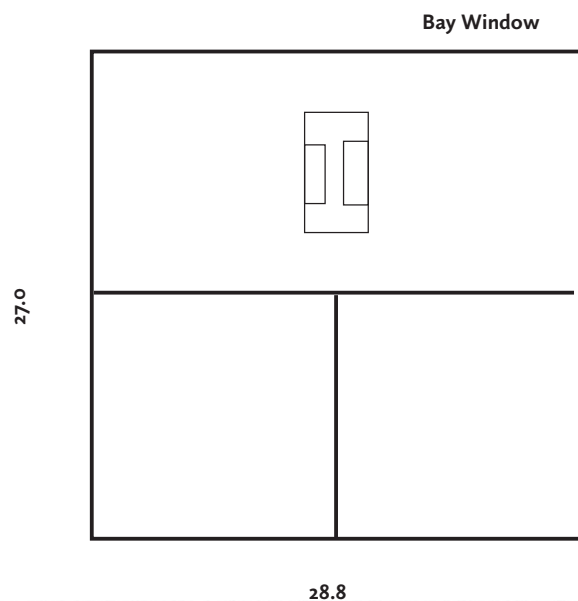
South side Bones Lane set up on bank. Single storey building of three elements: main range east/west, with central 2-flue stack; two short wings at right angles to northern elevation. No fenestration on eastern elevation. Thatched with hips and tiles on lower parts of inner slopes. Malmstone and brick elevations.

Bay window to south-west corner, brick addition west. Internally, to north side of chimney, boarded cupboards with UH hinges. Roof space

Main range and wings constructed 'all of a piece', with an assortment of purlins, flying collars and raking struts, incorporating re-cycled material and some heavy pine elements that appear to be part of a later strengthening/repair process. Ridge boards throughout.
