29/31 North Lane

Statutory listing

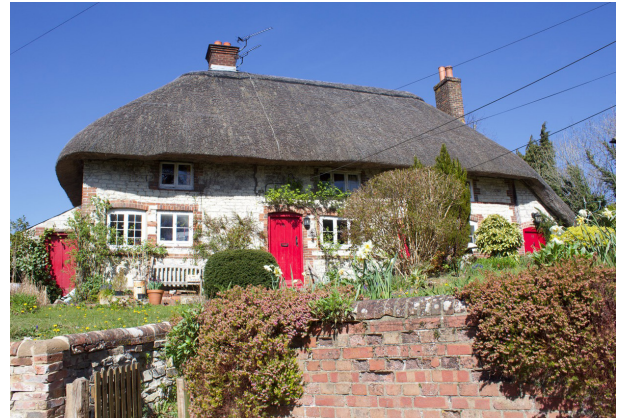
Modern single-storey additions

Visible framing

carpenter's marks (using circle/semi-circle) at C, and low mortices in studs. Original external framing visible BC (west) including arch-brace. The north end was not examined at this visit, but some information was available from the owner, and in a report of 1974 (Hallam). At first floor some bay posting visible with long tapered jowls; bay divisions at B and C, with crown struts. Edge-halved scarf joint in eaves plate (N); north of this a couple of peg holes that could indicate earlier window jambs.
