Garth Cottage and The Guard House, High Street

Description

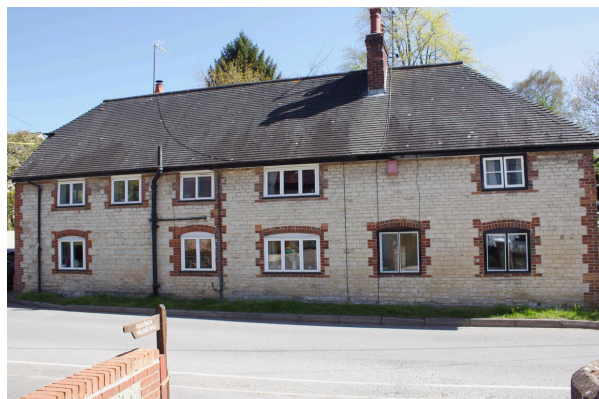
Cross-wing comprised of two bays, AB and BC. Some

evidence of ground floor partitioning at B, but first floor appears to have been open. No evidence remains for position of earliest stair.

Truss C has visible bay posts (rounded jowls) half-height tension bracing, regular square framing. Internally, fairly slender joisting and girders all visible. Some element of finish to joists in AB, remainder left square. Hearth with timber bressumer and remains of oven to north. Faint ritual markings towards southern end of bressumer.

Open stair now rises within BC, with first floor partition introduced at 'b'. Truss B appears to have been open; surviving (?replacement) arch-brace is nailed. Queen posts at B and edge of post at A are visible. First floor hearth now blocked.

The framing of Garth Cottage is sturdy, if not finely finished. Although fully floored and heated at two levels, it is unlikely to have stood alone. The diagnostic features of jowl profiles, pattern of wall-framing and bracing, and roof construction of queen posts to side-purlins, all point towards a dating of 1610/15, + or — 5. It would probably have functioned as a 'solar'.
