Glebe Cottage, Kiln Lane

Description

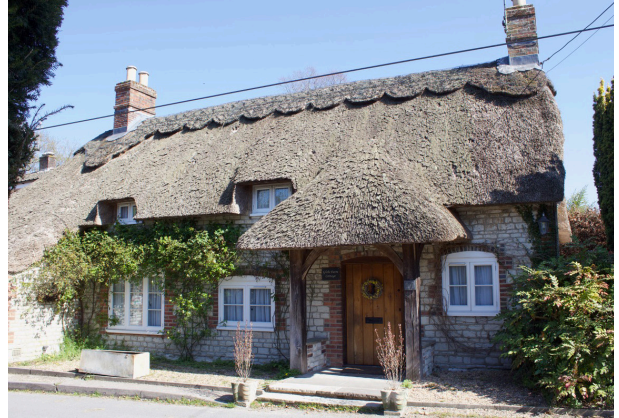
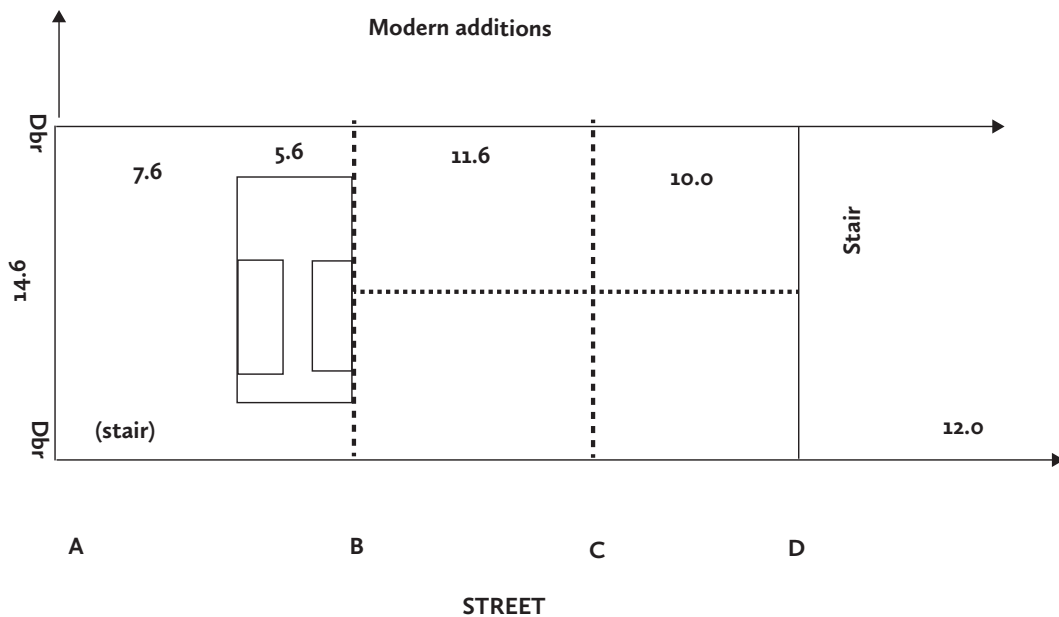
Aligned parallel with and on the east side of the street, thatched roof hipped each end; front elevation malmstone with brick trim. Framing visible on northern elevation includes bay posts with cut-back jowls, down-braced from the jowls. Earlier north of B onto side of stack. Later addition south of D now contains stair and entry. Old stair site at A (owner's info). Joisting ceiled in.

Mid-ties at C and D. Tie at B stop-chamfered but no evidence for partition on underside, so possibly contemporary with the stack. Axial girders BC & CD. Back-to-back hearths with stone jambs (blocked north of B) served by stack in AB, bread oven to east. At first floor ties visible at B and C each cut to the west for 'passage' through; bay post partially visible at B (east) with arch brace. Queen struts or peg eide

nce at B & C, and collar at C. Floor level changes at D. Roof

Visible from hatch within CD, heavy medieval rafters and side-purlins (sooted), also high collar for gablet of original hip from D. Similar (sooted) timbers visible from hatch in AB, also low collar pegged in at B and remains of wattle-and-daub partition at B.

This was a 3 bay house (A > B, B > C, C > D) that had clearly suffered from periods of neglect, and had at one time been condemned (owner's info). As it was not entirely clear from a single visit whether BC was a narrow bay in its own right, or evidence of the first phase of smoke control, but a second visit (2018) made the latter more likely (ie 1st phase smoke control against B). Diagnostic elements such as the plan, pattern of framing visible at A and roof construction taken with the sooted roof timbers suggested that the bay BC was originally an unfloored open hall, flanked by storeyed bays AB and CD. If these had original joisting it would probably be aligned longitudinally.

Constricted examination of the roof suggested that there had been a stage when a wattle-and-daub partition was constructed at B as part of smoke control above a hearth facing into BC, which subsequently had a first floor installed. (This partitioning may have been part of a closed truss at B, as the end of the hall). The chimney stack was eventually built into the same position, then serving back-to-back hearths.
