Rock Cottage

Statutory listing:

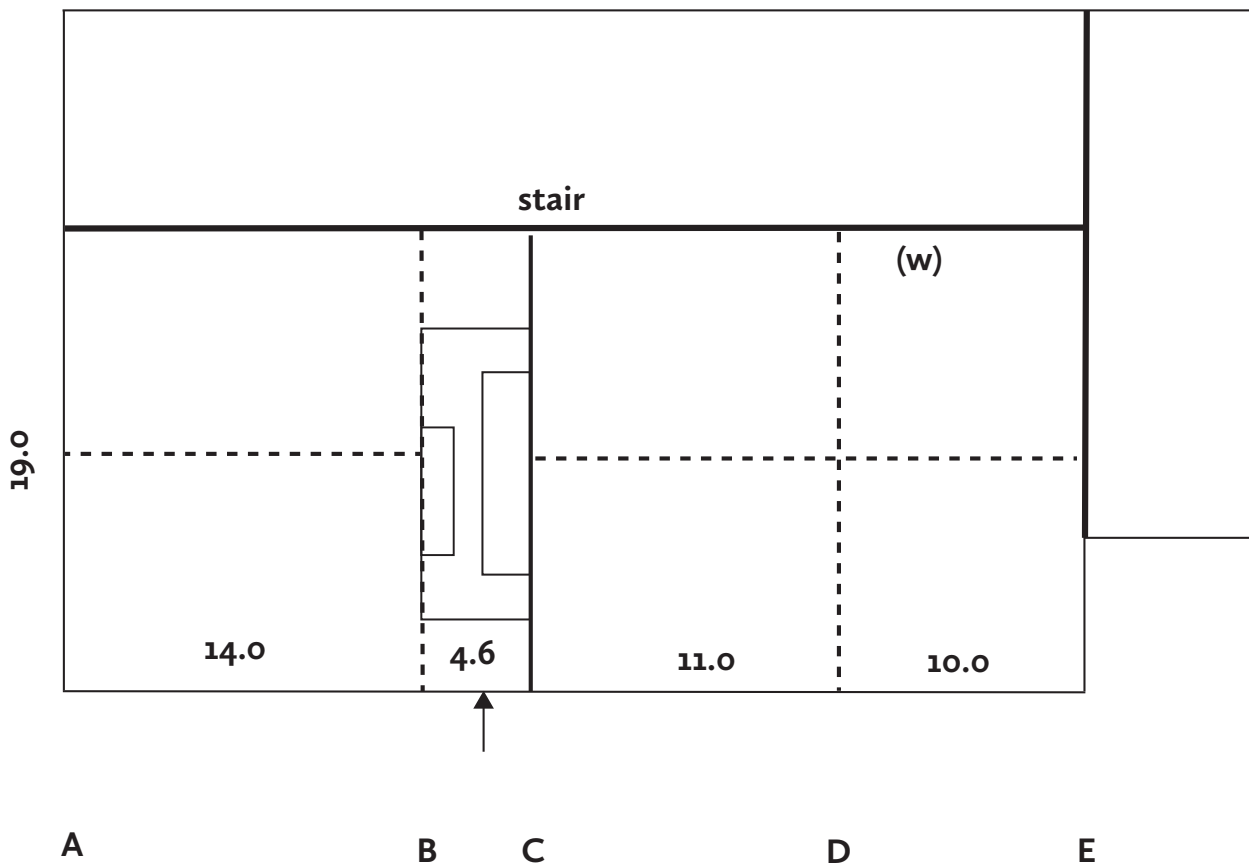
Baffle-entry into BC. Axial girders CD and DE are stop-chamfered (AB is boxed and ceiled) but joists are set high and without finish. Hearth with timber bressumer at C, but heavy stone jambs mark the width of the original bressumer. Stair now rises within outshot, turning into BC. First floor

Trusses C and D visible to collar height with tall queen posts. Heavy central post at D has taper burn marking; hearth at C now blocked. Small 3-light unglazed window with diamond set wooden mullions between DE now blocked by catslide. Ties at C and D cranked at the rear with identical elbow-like bend. Roof lined but heavy rafters partially visible, and probably pegged apex. Flying collar of rough timber over AB.

Well-proportioned house with six living spaces, but no true attic space. Echoes medieval plan of solar (AB) 2bay hall (BD) and service (DE). Probably fully framed initially. Set of joists within CD, taken with nail holes and lack of finish suggest original ceilings probably plastered (socially significant). Timber of good scantling, but cranked feature to ties C & D unique; possibly reflection of difficulties obtaining good lengths of timber. A baffle-entry house; original stair probably a winder within BC (rear). Some features probably compromised during periods of multiple occupation.
