Lawn Cottage, North Lane

Statutory listing:

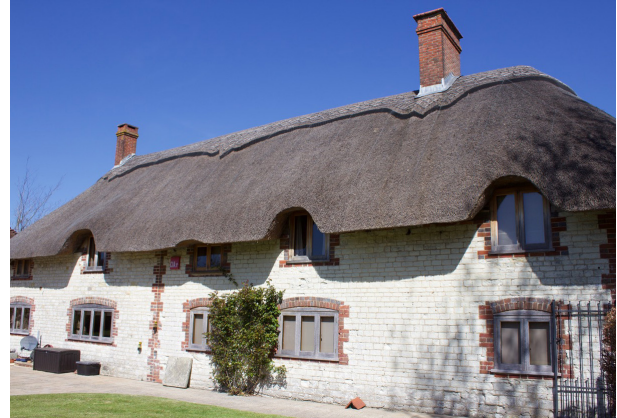
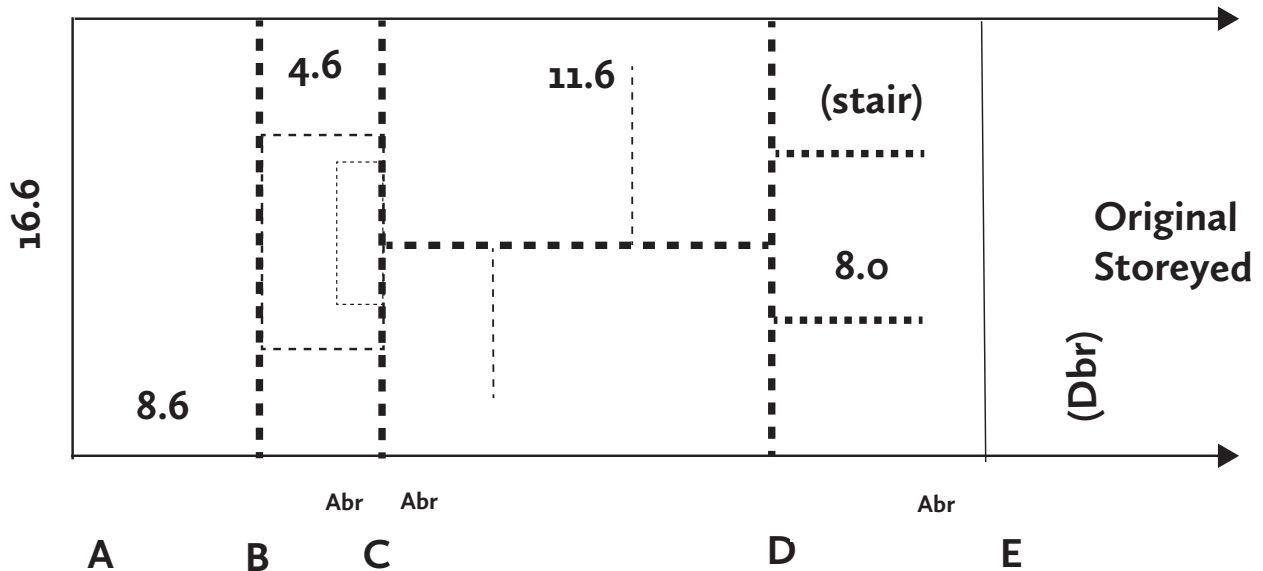
Parallel with and on the south side of the highway, set up on the bank; thatched above facing/infill of malmstone with brick. Modern additions to the west. Timber-framing, now infilled with malmstone, visible on north-east elevation; rafter feet indicate original extended up to end elevation. Arch-bracing (Abr) where

indicated with wattle-and-daub surviving at C. Some traces of red ochre on timbering, including cill. Single bay-post seen at E (north) with mortice, presumably for corner down brace; tie and vertical studs at E faced westwards.

West of E originally single storey, floor inserted consisting of re-cycled barn timbers (owner's info.) DE joisted longitudinally, heavy scantling, evidence for stair trimmer (south); stud and stave mortices on underside of mid-tie at D. CD has axial girder, stop-chamfered, supported by stack.

Four bay house, originally with 2-bay central unfloored hall (B > D) flanked by floored bays; services (AB) & solar (DE). Narrow hall bay (BC) probably accommodated cross entry. Photographs provided by the owner confirmed roof structure of queen struts & side-purlins, sooting and tapered jowl profiles; taken with the pattern of framing and plan these suggest original build towards end of 1400s. Rare to find evidence of colouring. Chimney built into narrow bay and hall floored in early 1600s, when BC could have become a baffle entry. Scantling and bracing similar to 29/31 North Lane.
